RISER PROTECTION

Hardbanding halts deepwater wear

Rupture of deepwater drilling risers could be devastating. Fortunately, proper modeling and hardbanding can prevent it.

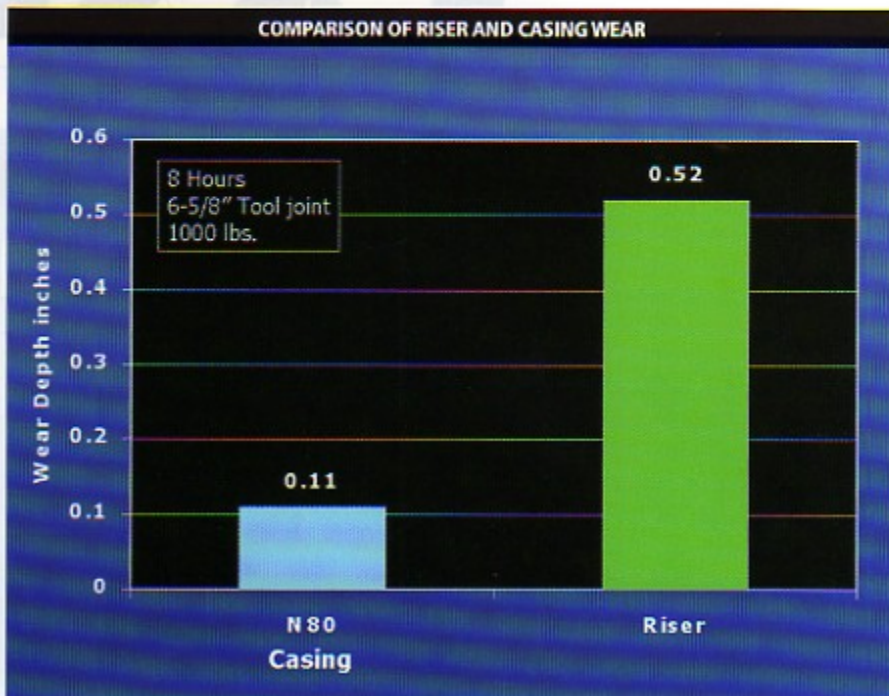
Figure 1. Riser materials wear up to five times faster than casing materials with comparable physical properties.

The precise relationship between several critical variables must be considered to prevent riser wear effectively while drilling in ultradeep waters. The deeper the water, the greater the potential for catastrophic occurrences resulting from wear caused by high drillstring tension pulling the rotating tool joints against the curved sections of the riser. Furthermore, tests on casing and risers have demonstrated riser materials wear up to five times faster than casing materials with comparable physical properties (Figure 1).
